# BUILDING SYSTEMS ASSESSMENT

**Riverdale Presbyterian Church  
6513 Queens Chapel Road  
University Park, MD 20782**

**December 3, 2013**

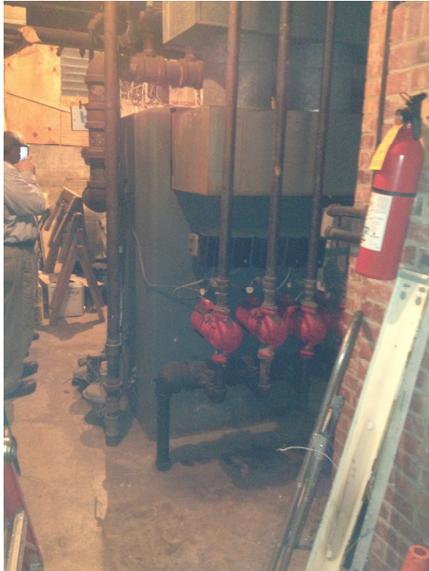
**Photo 1: Boiler B-5 with Inline Pumps**

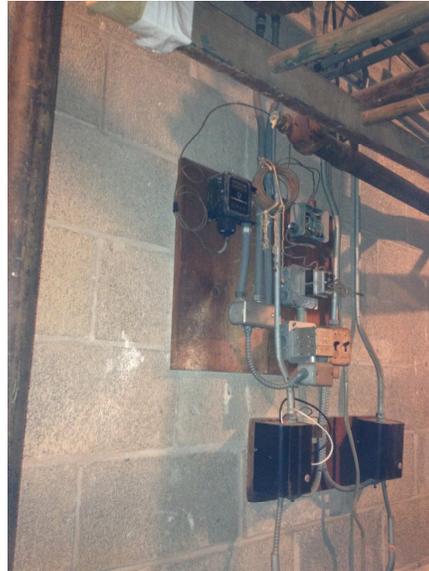
**Photo 2: Controls for Boiler B-5**

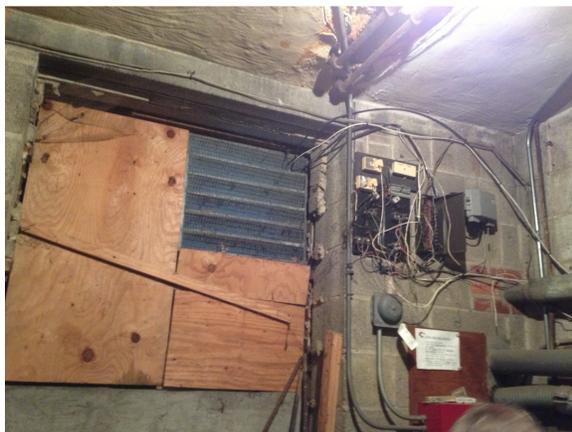
**Photo 3: Louver for Combustion Air for Boiler B-5**

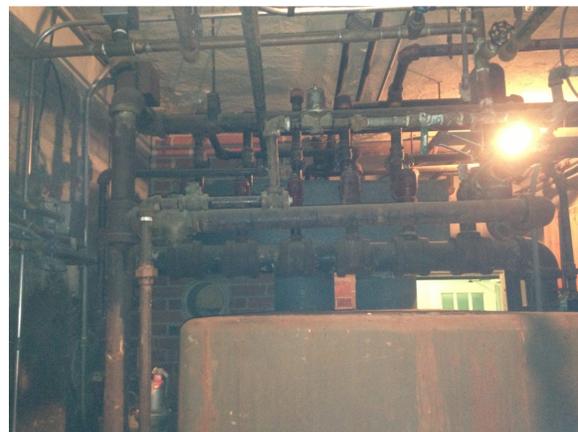
**Photo 4: Uninsulated Piping in Annex Mechanical Room**

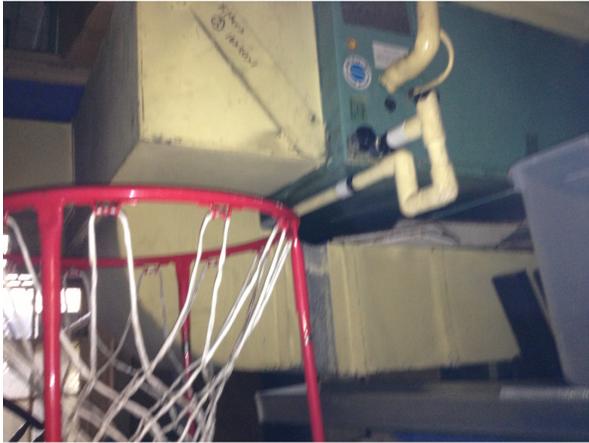
- (ii) A gas furnace (GF-1) provides heating capabilities in the Fellowship Hall, but its flue vent is improperly installed.
      - (iii) Door louvers of the Storage Room, where AC-2 and AC-3 are installed, serve as a means of return air for AC-2. Thus the storage room is being used as a return air plenum. A storage room with combustible construction cannot be used as a return air plenum.

**Photo 5: Air Conditioning Units (AC-1 and AC-2) in the Storage Room**

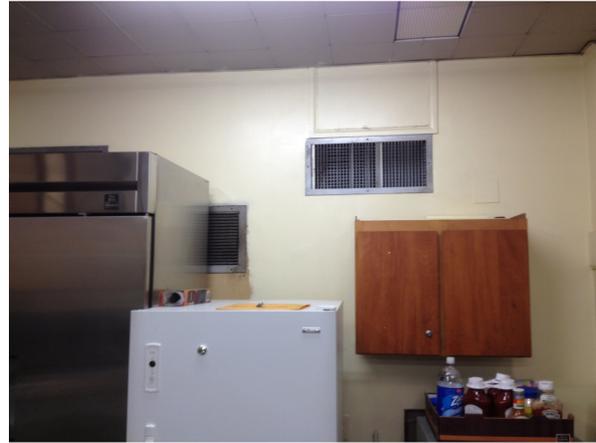
- (i) Supply and return air registers are on the same wall which does not provide proper air circulation in the space.
      - (ii) There is no fire protection (Ansul type) system and make-up air unit for the kitchen hood.

**Photo 6: Supply and Return Air Registers in the Kitchen**

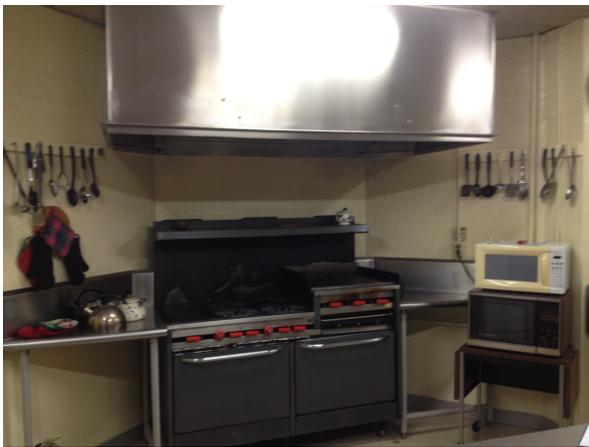
**Photo 7: Kitchen Hood**

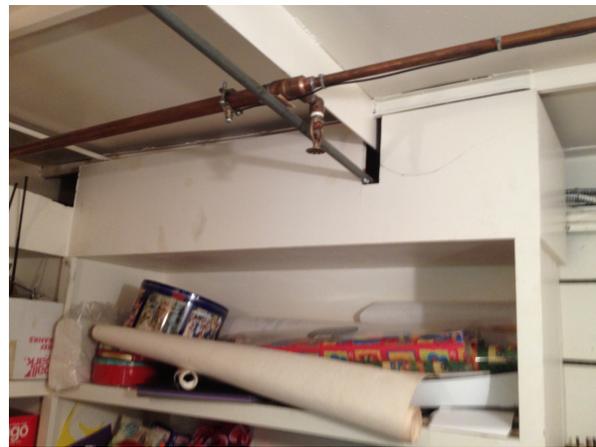
**Photo 8: Limited Area Sprinkler System**

Based on code analysis, it is recommended that the building should be fully sprinkled in compliance with applicable codes including, but not limited to, International Building Code Para 504.2 and NFPA 13.

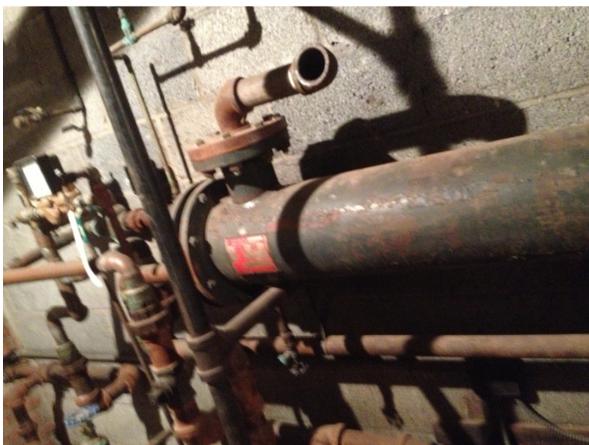
**Photo 9: Steam to Hot Water Heat-Exchanger**

- e. For the hot water system, the existing heat-exchanger and associated pumps should be replaced to serve both buildings.

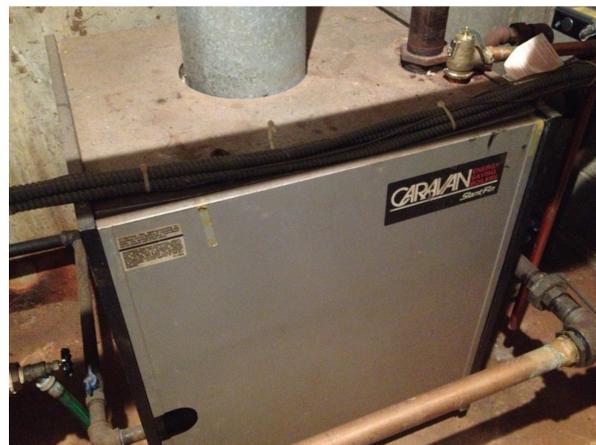
Boilers, B-1 thru B-4	Slant Fin	Caravan, GX300Z	300 MBH Heating Capacity Each/ Gas Fired	Fair Condition. 23 Years Old Units	25 Years

**Photo 10: Steam Boilers (B-1 Through B-4)**

- (i). Option #1: If the renovation of the Sanctuary, Balcony, and Offices is scheduled for the future, then existing boilers (B-1 thru 4) should serve both buildings. This will allow continuity of the Church's activities in the building during the renovation of rest of the building.

- (ii) Option #2: Existing boilers should be replaced by high efficiency hot water boilers if both buildings are renovated in one phase.
  - d. Four pipe chilled and hot water system will help in the phased construction of the project as the Church may continue to use the Sanctuary, Raised Alter, Balcony, and Offices using its existing HVAC system (AC-3 and CU-4) and radiators, while the rest of the building is under renovation for the Town.

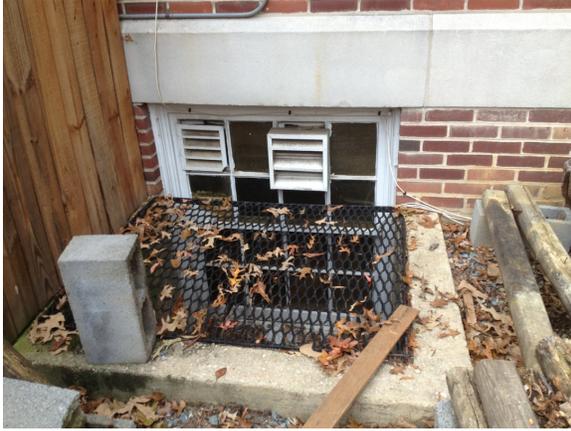
- (iv) A very small duct is providing outside air for AC-2 which is not equipped with economizer controls.
      - (v) Common areas are not properly ventilated.

**Photo 11: Outside Air Intakes for AC-1 and AC-2**

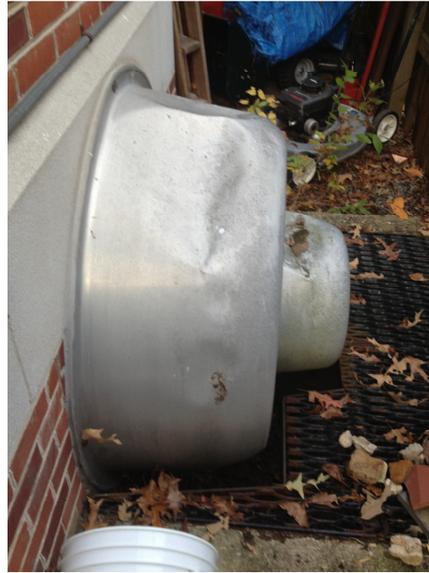
**Photo 12: Wall-Mounted Kitchen Exhaust Fan**

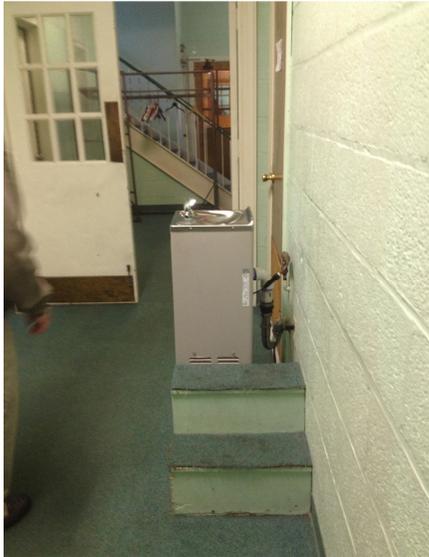
- F. Electrical Water Coolers (EWC): One EWC with exposed water and sewer piping is provided on each floor of the Annex Building, but are not in compliance with ADA requirements.
- G. Water: Uninsulated copper piping is provided for most of the cold and hot water systems.
- H. Sewer: Cast iron piping is used for sewer piping.
- I. Storm Water System: Consisting of gutters and down spouts which are either connected to boots or spilling on grade. Most of the down spouts are in very poor conditions and should be replaced.
- J. Floor drains are provided without trap primers.

**Photo 13: Non-ADA Electric Water Cooler with Exposed Piping**

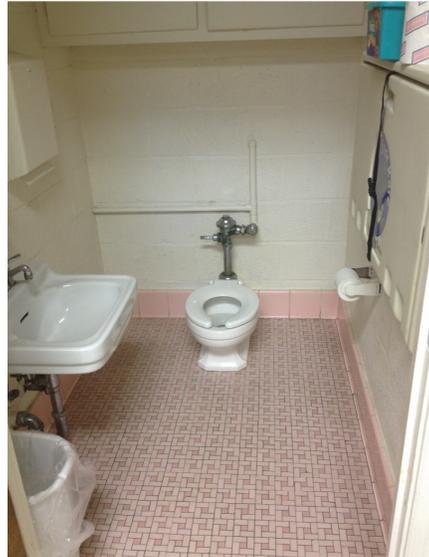
**Photo 14: Existing Plumbing Fixtures**

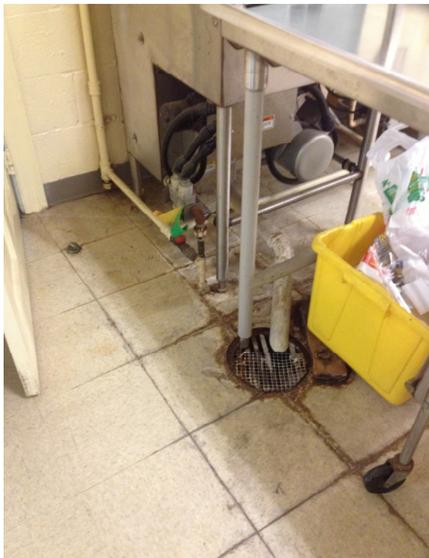
**Photo 3: Plumbing Piping and Drain Without Any Grease Interceptor**

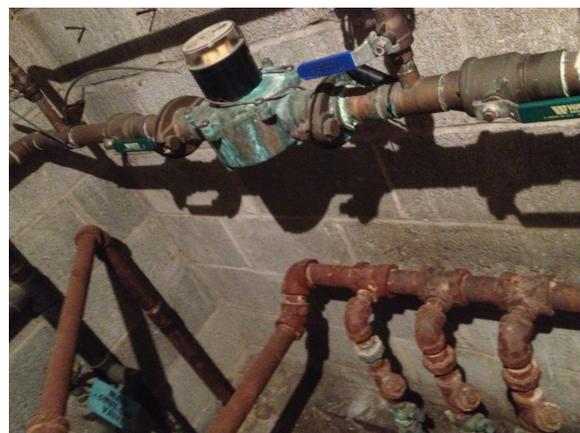
**Photo 4: Incoming Water Service and Meter**

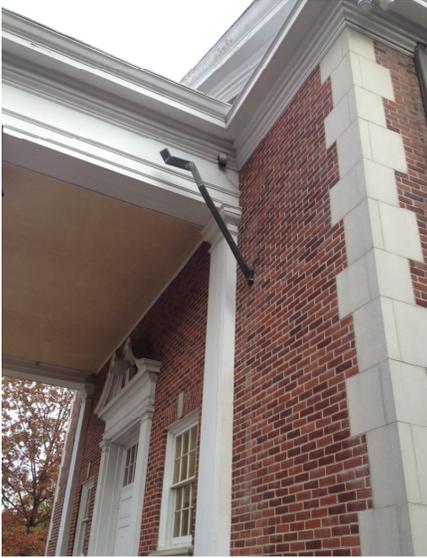
**Photo 5: Damaged Downspout**

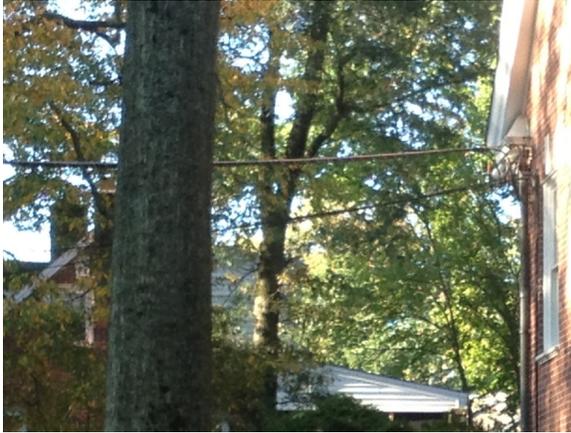
**Photo E1: Overhead In-Coming Service**

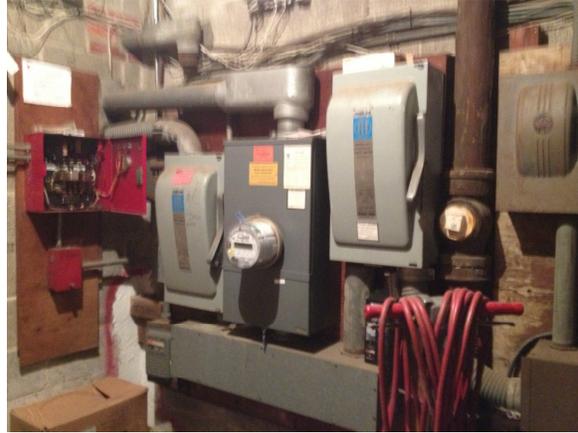
**Photo E2: In-coming Three Phase System and Fire Alarm Panel**

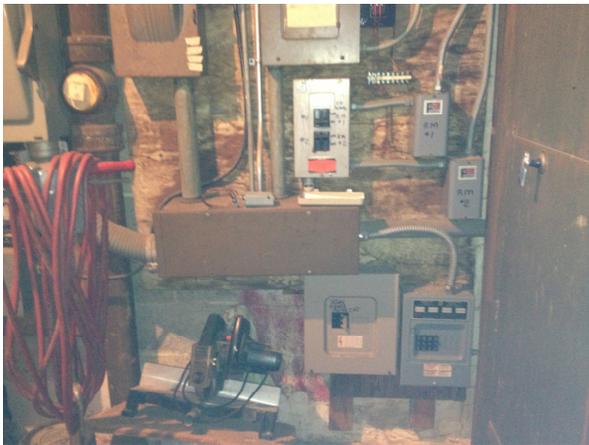
**Photo E3: Single Phase Distribution System**

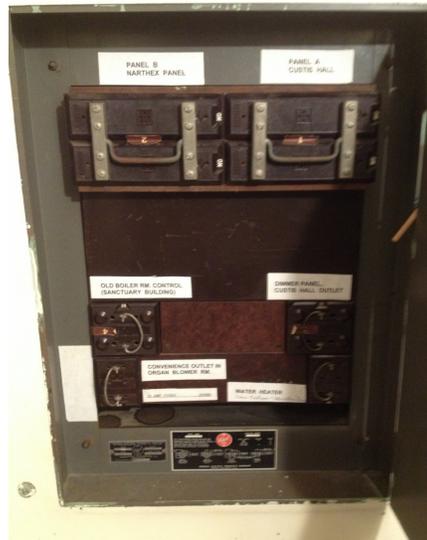
The Church side of the building is served by an existing 200A, 1 $\phi$ , 3W distribution panel (see Photo E4) located in the Staircase Closet on the Ground Floor. The distribution panel is original to the Church side of the building which was constructed in 1950 and probably relocated to the Staircase Closet after the construction of the Annex. It is a Federal Noark type fused panelboard with fused connections for branch circuit panels located in the Vestibule and the Fellowship Hall. Both branch circuit panels are in poor condition. The panelboard in the Fellowship Hall (see Photo E5) has life safety issues with two wooden blocks being used as space filler in the panel.

**Photo E4: Church Distribution Panel**

Given the age and the poor condition of the panels as well as capacity limitations, it is highly recommended that the entire distribution system be upgraded and replaced with new. Phasing should not be considered as all of the existing 1 $\phi$ , 3W electrical panels need to be replaced with new 3 $\phi$ , 4W panels. The recommended size of the new service is estimated to be 1200A.

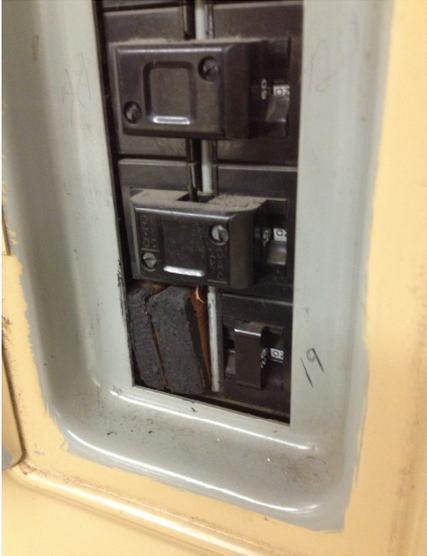
Photo E5: Painted Wooden Blocks Inserted into Panel

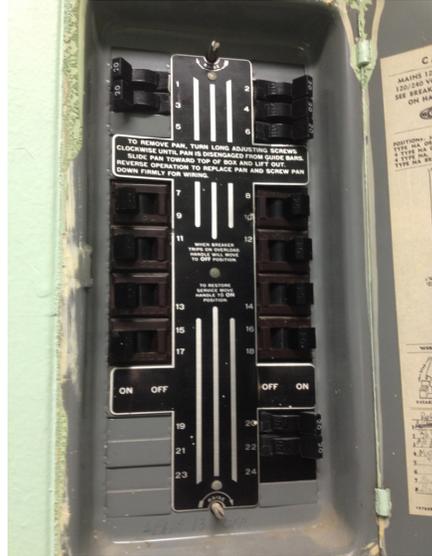
Photo E6: Annex Second Floor Panel

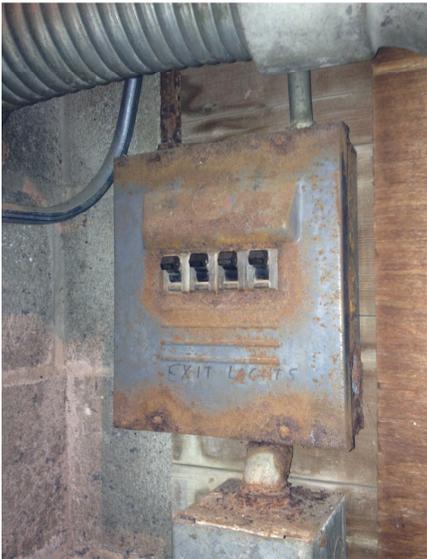
Photo E7: Emergency Lighting Load Center

Replace the entire emergency system and integrate the emergency lighting circuits for the majority of the building into localized panels.

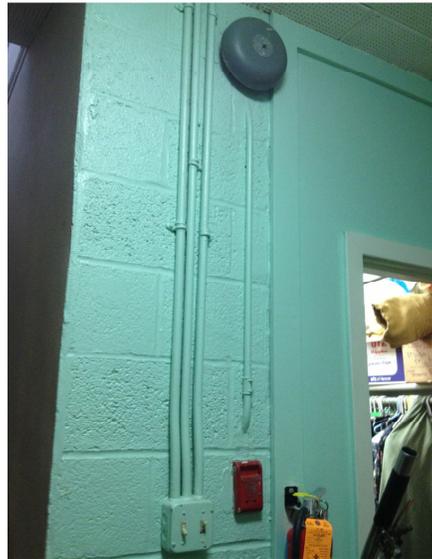
Photo E8: Fire Alarm Pull Station and Bell

Because of the age, condition, and function limitations of the systems available, a new fire alarm system shall be installed throughout with both detection and notification circuits to meet current code requirements. The new elevator shall be interconnected to a detection circuit for recall purposes. The kitchen range (should it remain) needs to be equipped with a fire suppression system.

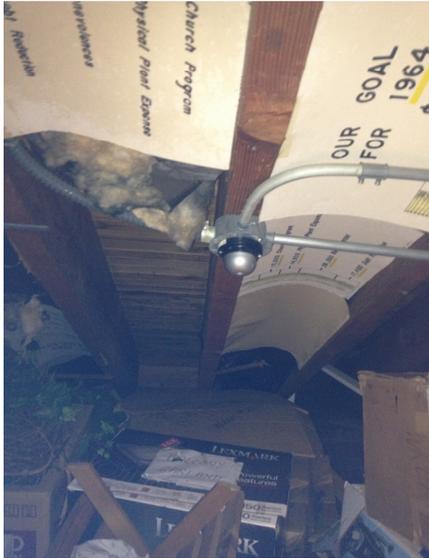
Photo E9: Small Fire Alarm Bell Located in Closet

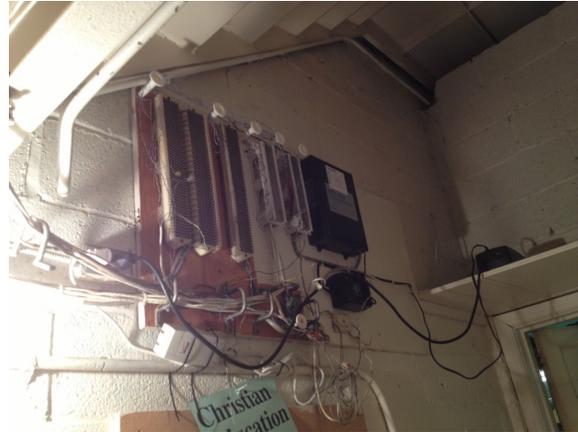
The existing building has a limited telecommunications system (see Photo E10) consisting mostly of telephone outlets located in the majority of rooms. Telecommunication cabling is being run unconcealed along and through walls (see Photo E11). Cable TV cabling and associated wireless router (see Photo E12) was noted in a room on the Second Floor of the Annex, but it unclear if it serves the entire building.

Photo E10: Telecommunications Baseboard

The existing telecommunication system is inadequate for the needs of the new Town Hall. The expectation to provide wireless routers throughout the Annex and Ground Floor of the Church Building would require an entirely new telecommunication system and network. Coordination between the telecommunication service utilities and the Town IT department would be required to determine exact system design requirements and scope of work.

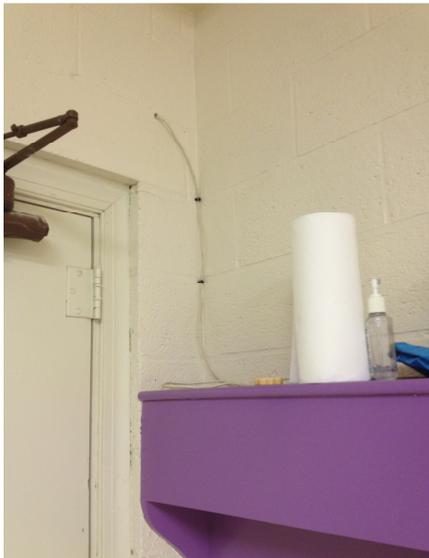
Photo E11: Unconcealed Telecommunication Cabling

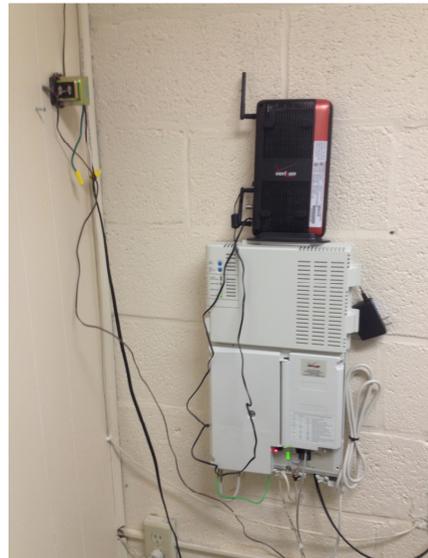
Photo E12: Cable TV

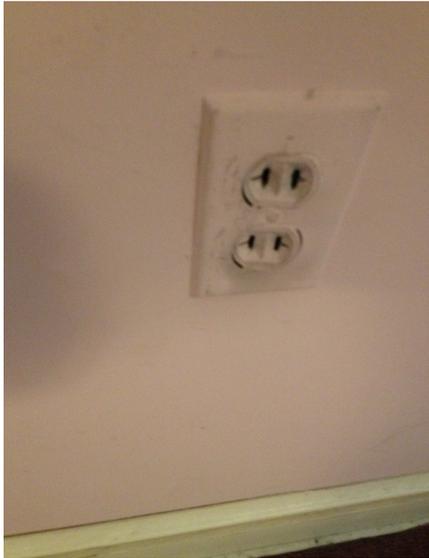
Receptacles have been painted over (see Photo E13) in several of the rooms, making for life safety concerns. Several of the receptacles seem to be original to the building construction. Receptacle faceplates are missing or show signs of rust and degradation in various rooms and locations.

**Photo E13: Receptacle with Painted Face**

It is suggested that the receptacles, faceplates, and associated wiring be removed and replaced with new throughout the building. GFCI type receptacles shall be installed in the kitchens and bathroom areas.

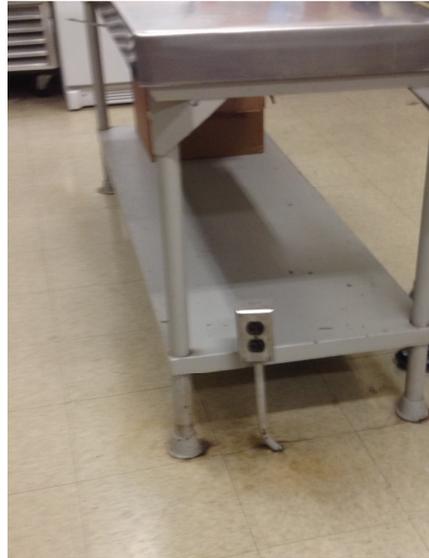
**Photo E14: Non-GFCI Receptacle in Kitchen**

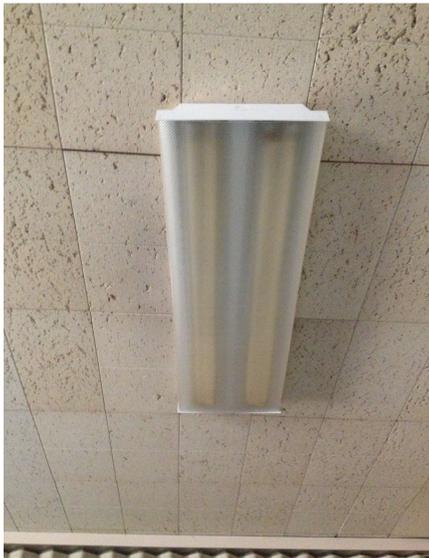
**Photo E15: Burn Patterns on Acrylic Lens**

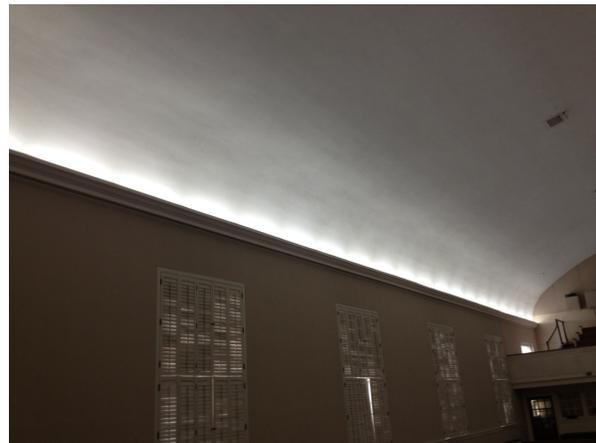
**Photo E16: Sanctuary Cove Lighting**

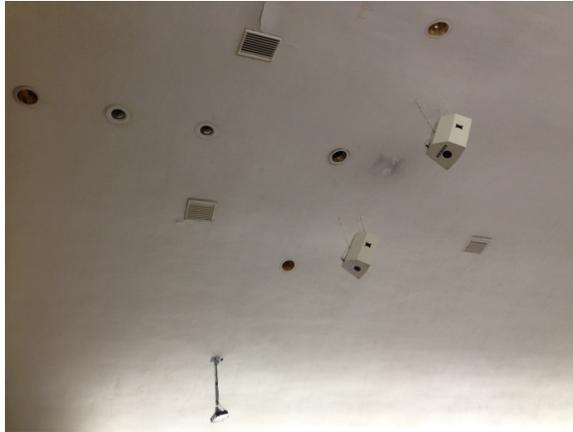
**Photo E17: Sanctuary Downlights**

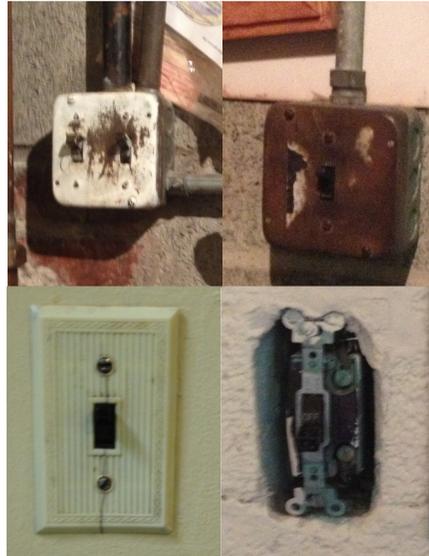
Faceplates for existing toggle switches in many rooms are rusted, broken, or missing (see Photo E18)

**Photo E18: Various Toggle Switches**

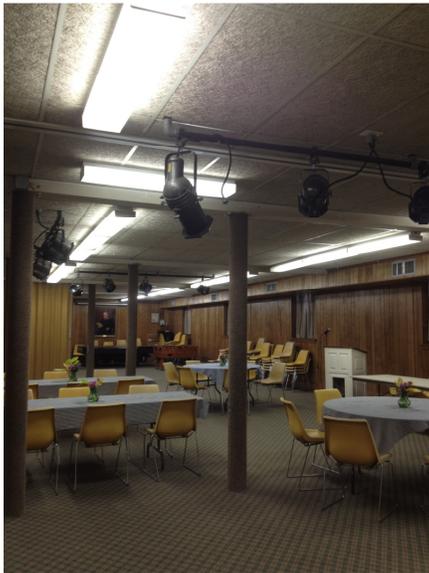
The Fellowship Hall is also used for theater and play productions and have theatrical lighting fixtures hanging at  $\pm 6'-6"$  AFF which is a building code violation (see Photo E19).

**Photo E19: Low Hanging Theater Lighting**

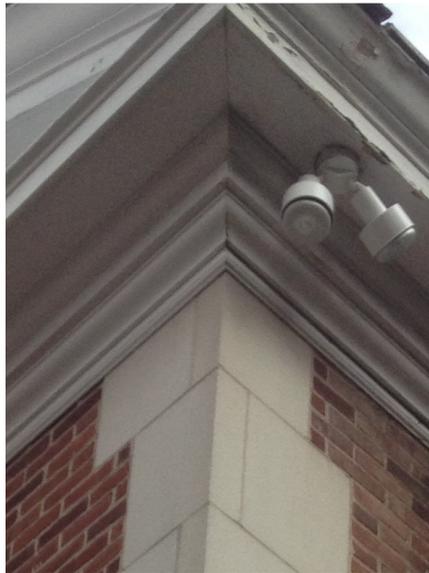
**Photo E20: Double Headed Exterior Fixture**

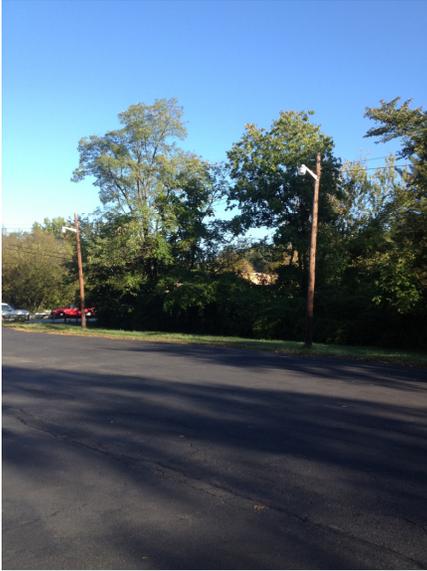
**Photo E21: Parking Lot Lighting on Utility Poles**

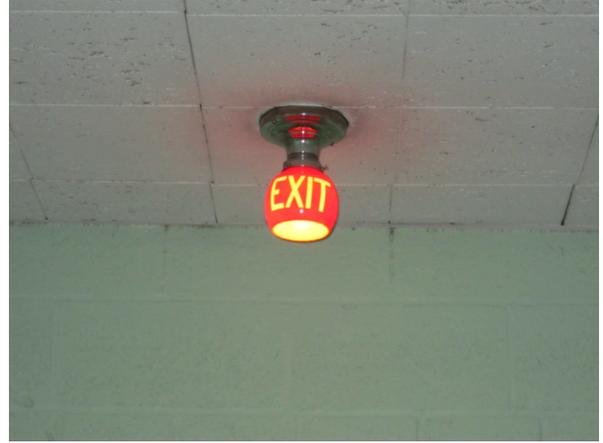
**Photo E22: Non-Standard Exit Sign**
