**HAZARDOUS MATERIALS SURVEY REPORT FOR  
RIVERDALE PRESBYTERIAN CHURCH AND ANNEX  
6513 QUEENS CHAPEL ROAD  
UNIVERSITY PARK, MARYLAND 20782**

**TOWN OF UNIVERSITY PARK  
6724 BALTIMORE AVENUE  
UNIVERSITY PARK, MARYLAND 20782**

**ARIA ENVIRONMENTAL, INC.  
PO BOX 286  
WOODBINE, MD 21797**

**DECEMBER 6, 2013**

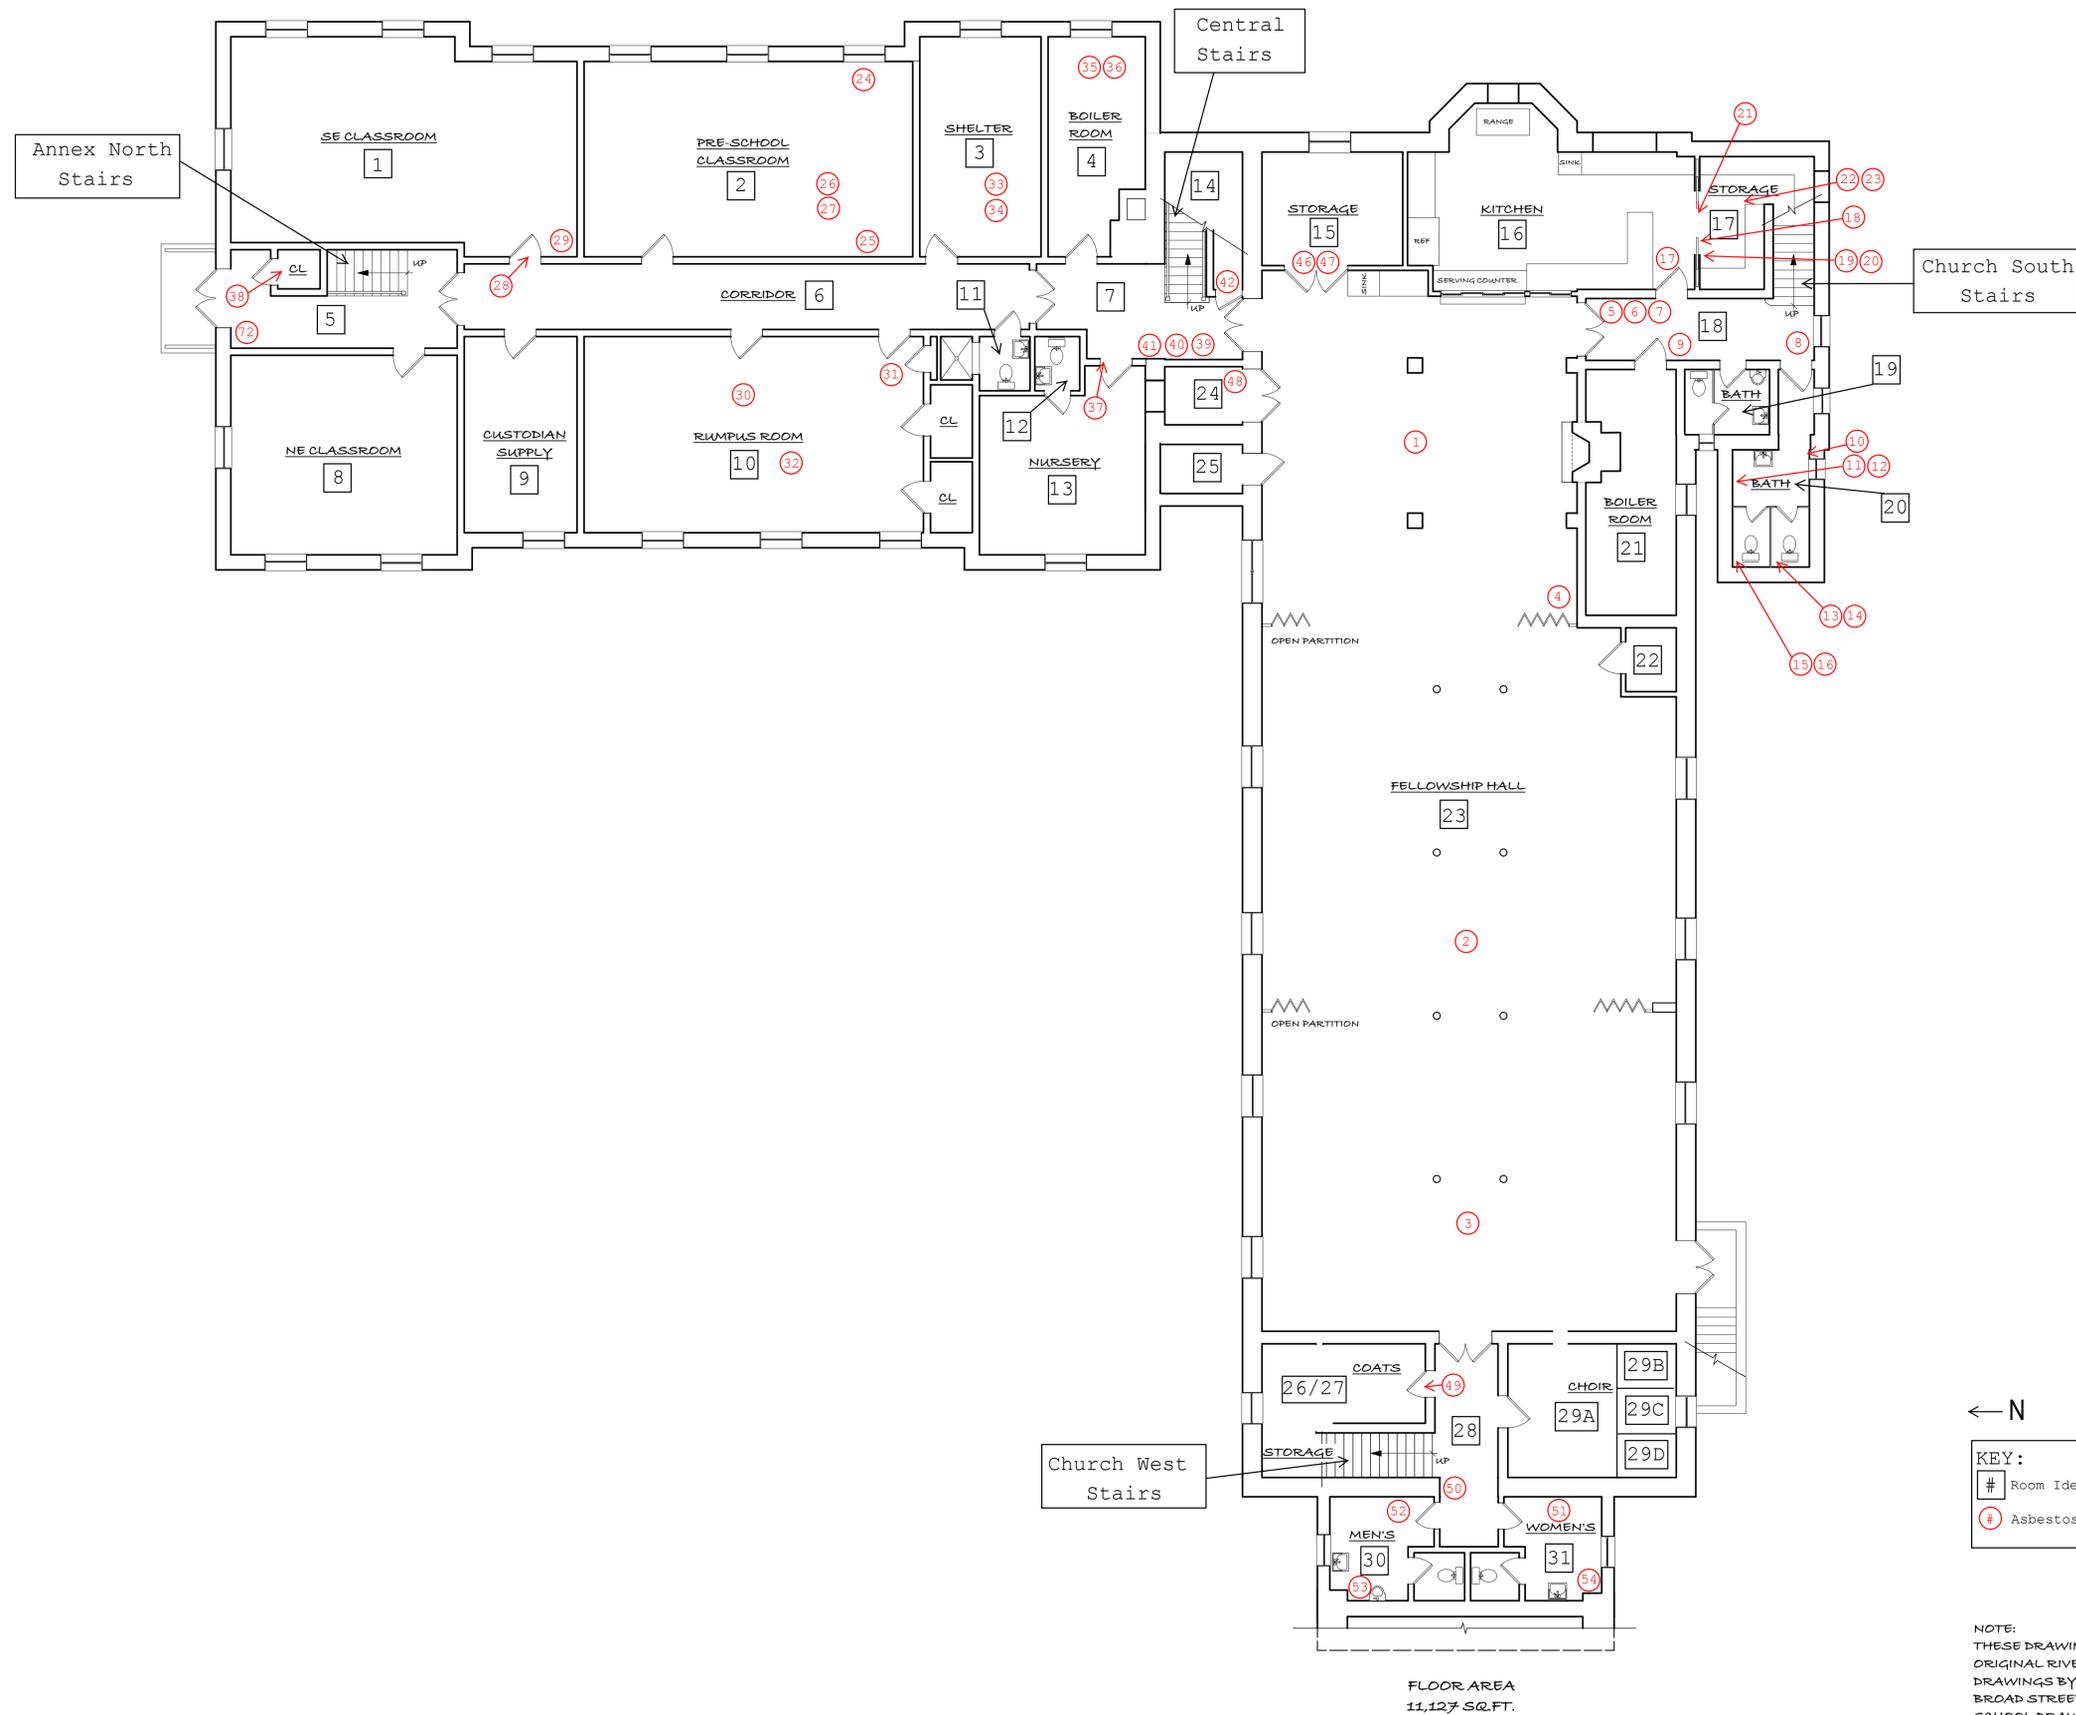
**1** EXISTING GROUND FLOOR  
Scale: 1/8" = 1'-0"

**KEY:**  
 # Room Identification Number  
 # Asbestos Sample Locations

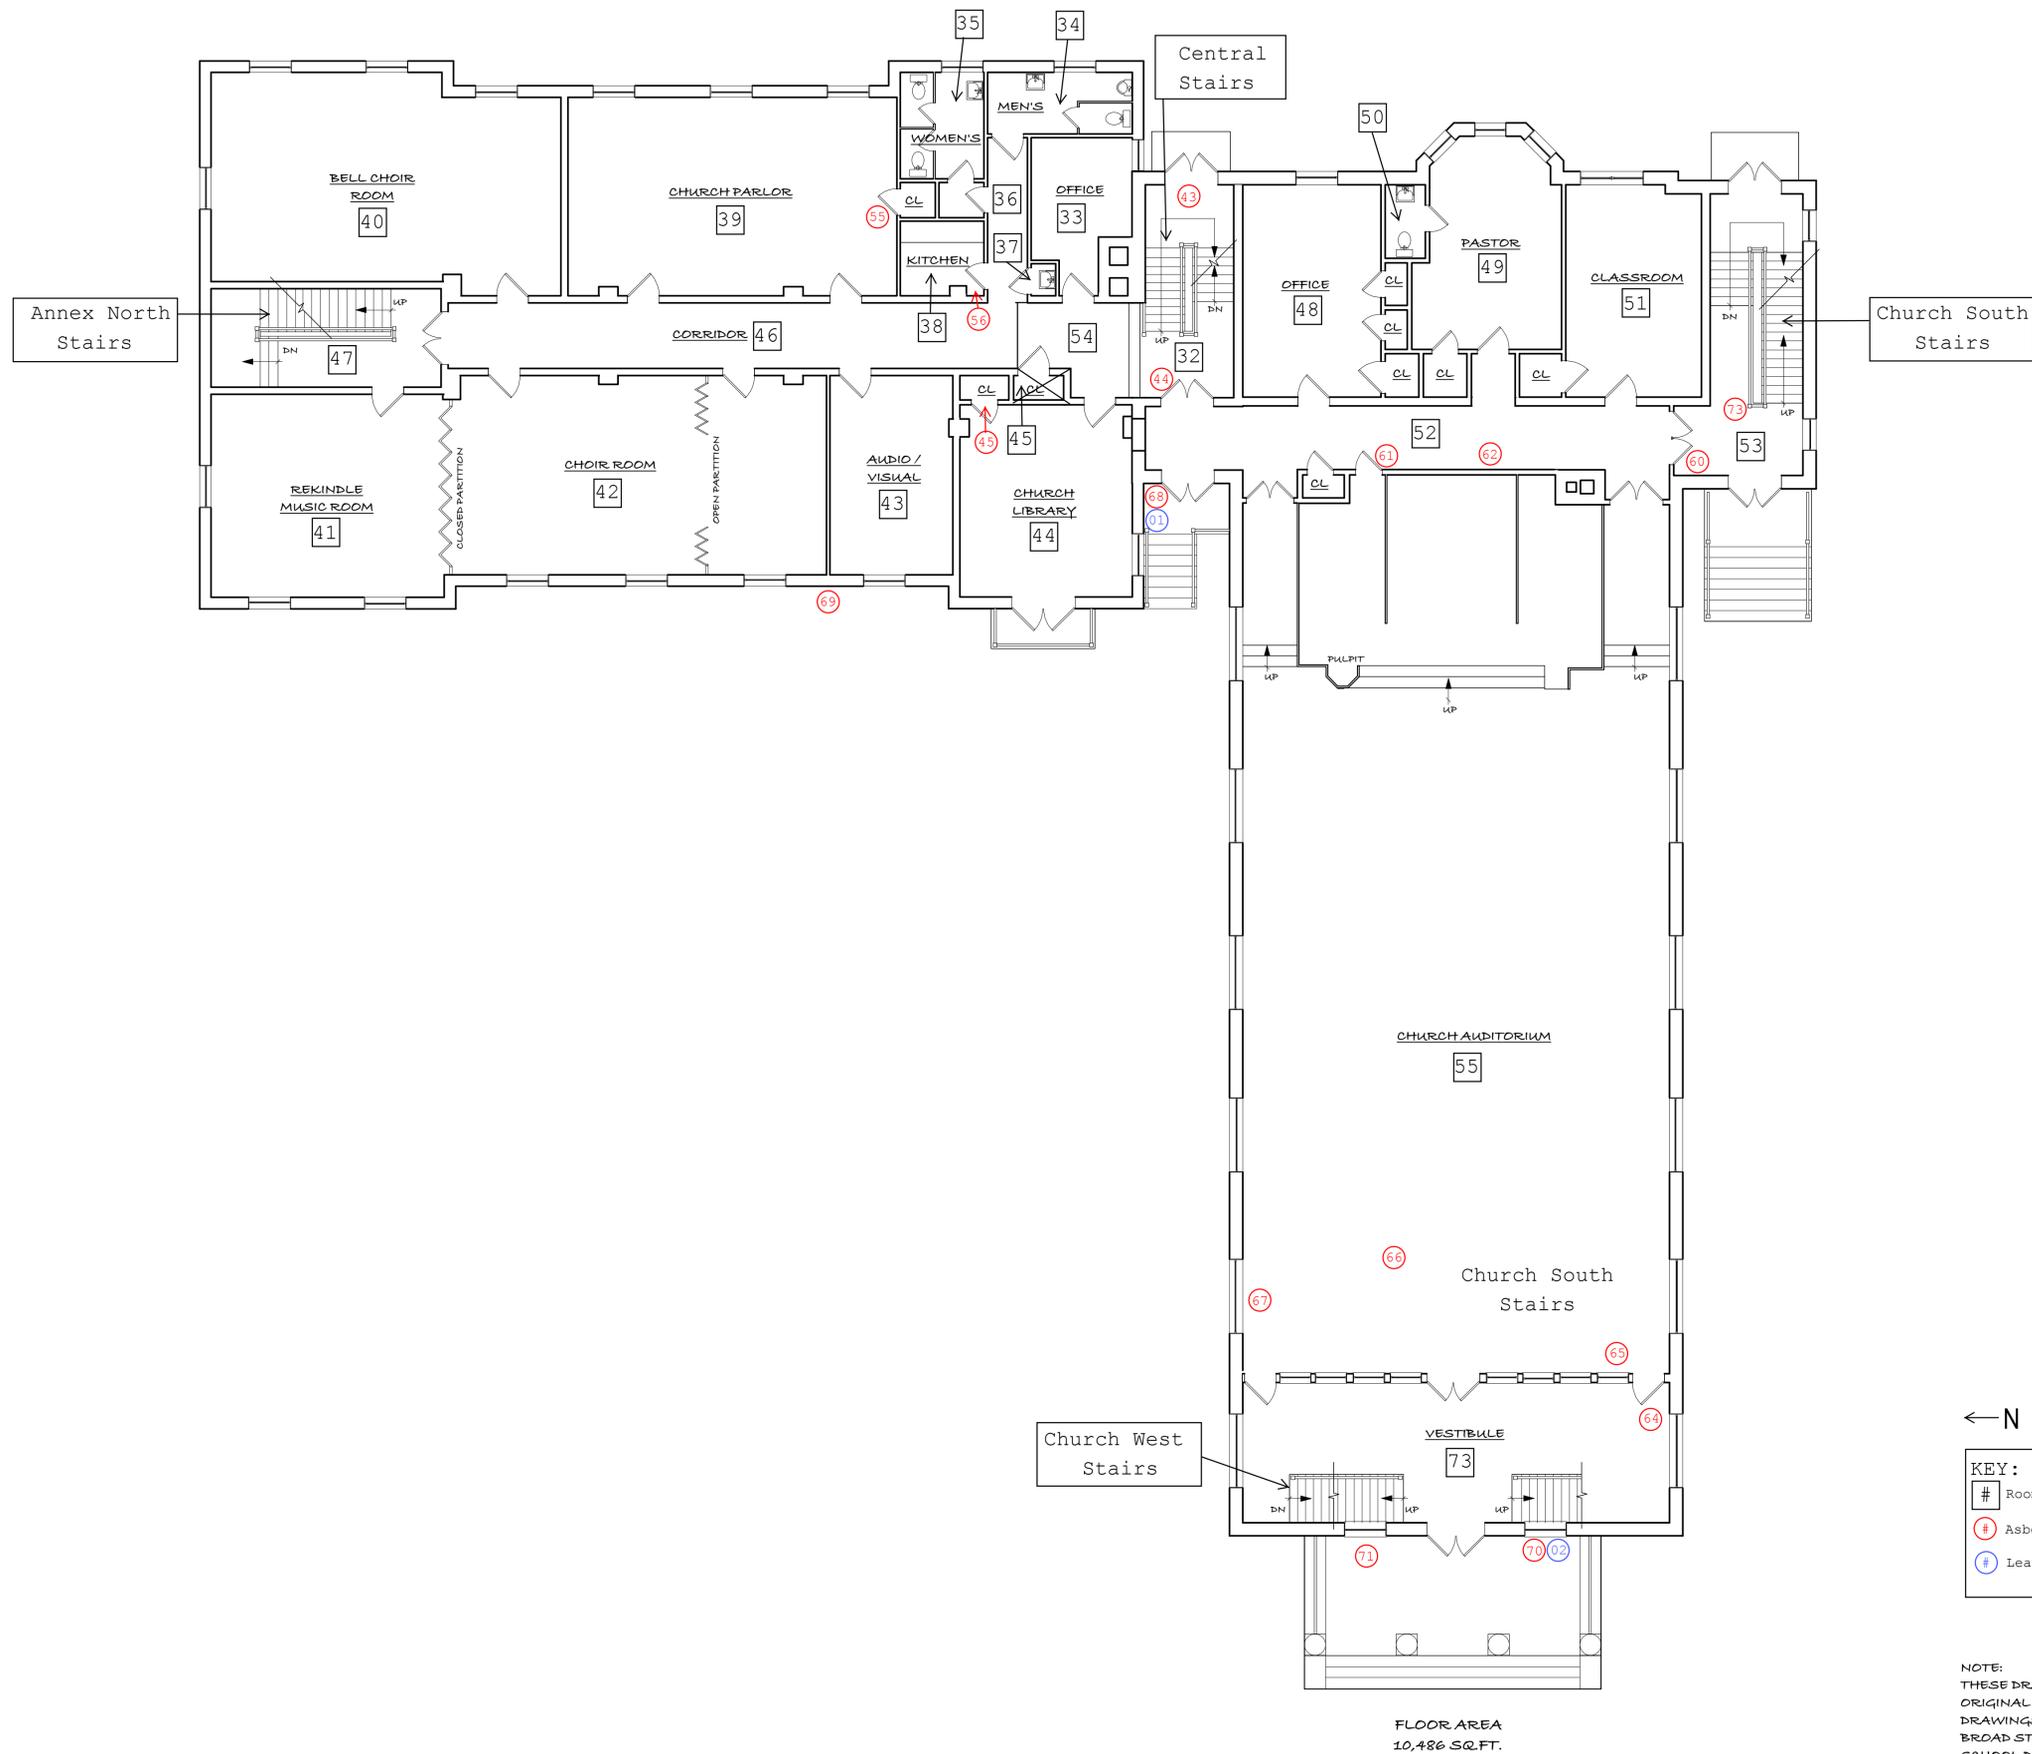
**1** EXISTING FIRST FLOOR  
Scale: 1/8" = 1'-0"

FLOOR AREA  
10,486 SQ.FT.

#	Room Identification Number
⊘	Asbestos Sample Locations
⊙	Lead Sample Locations

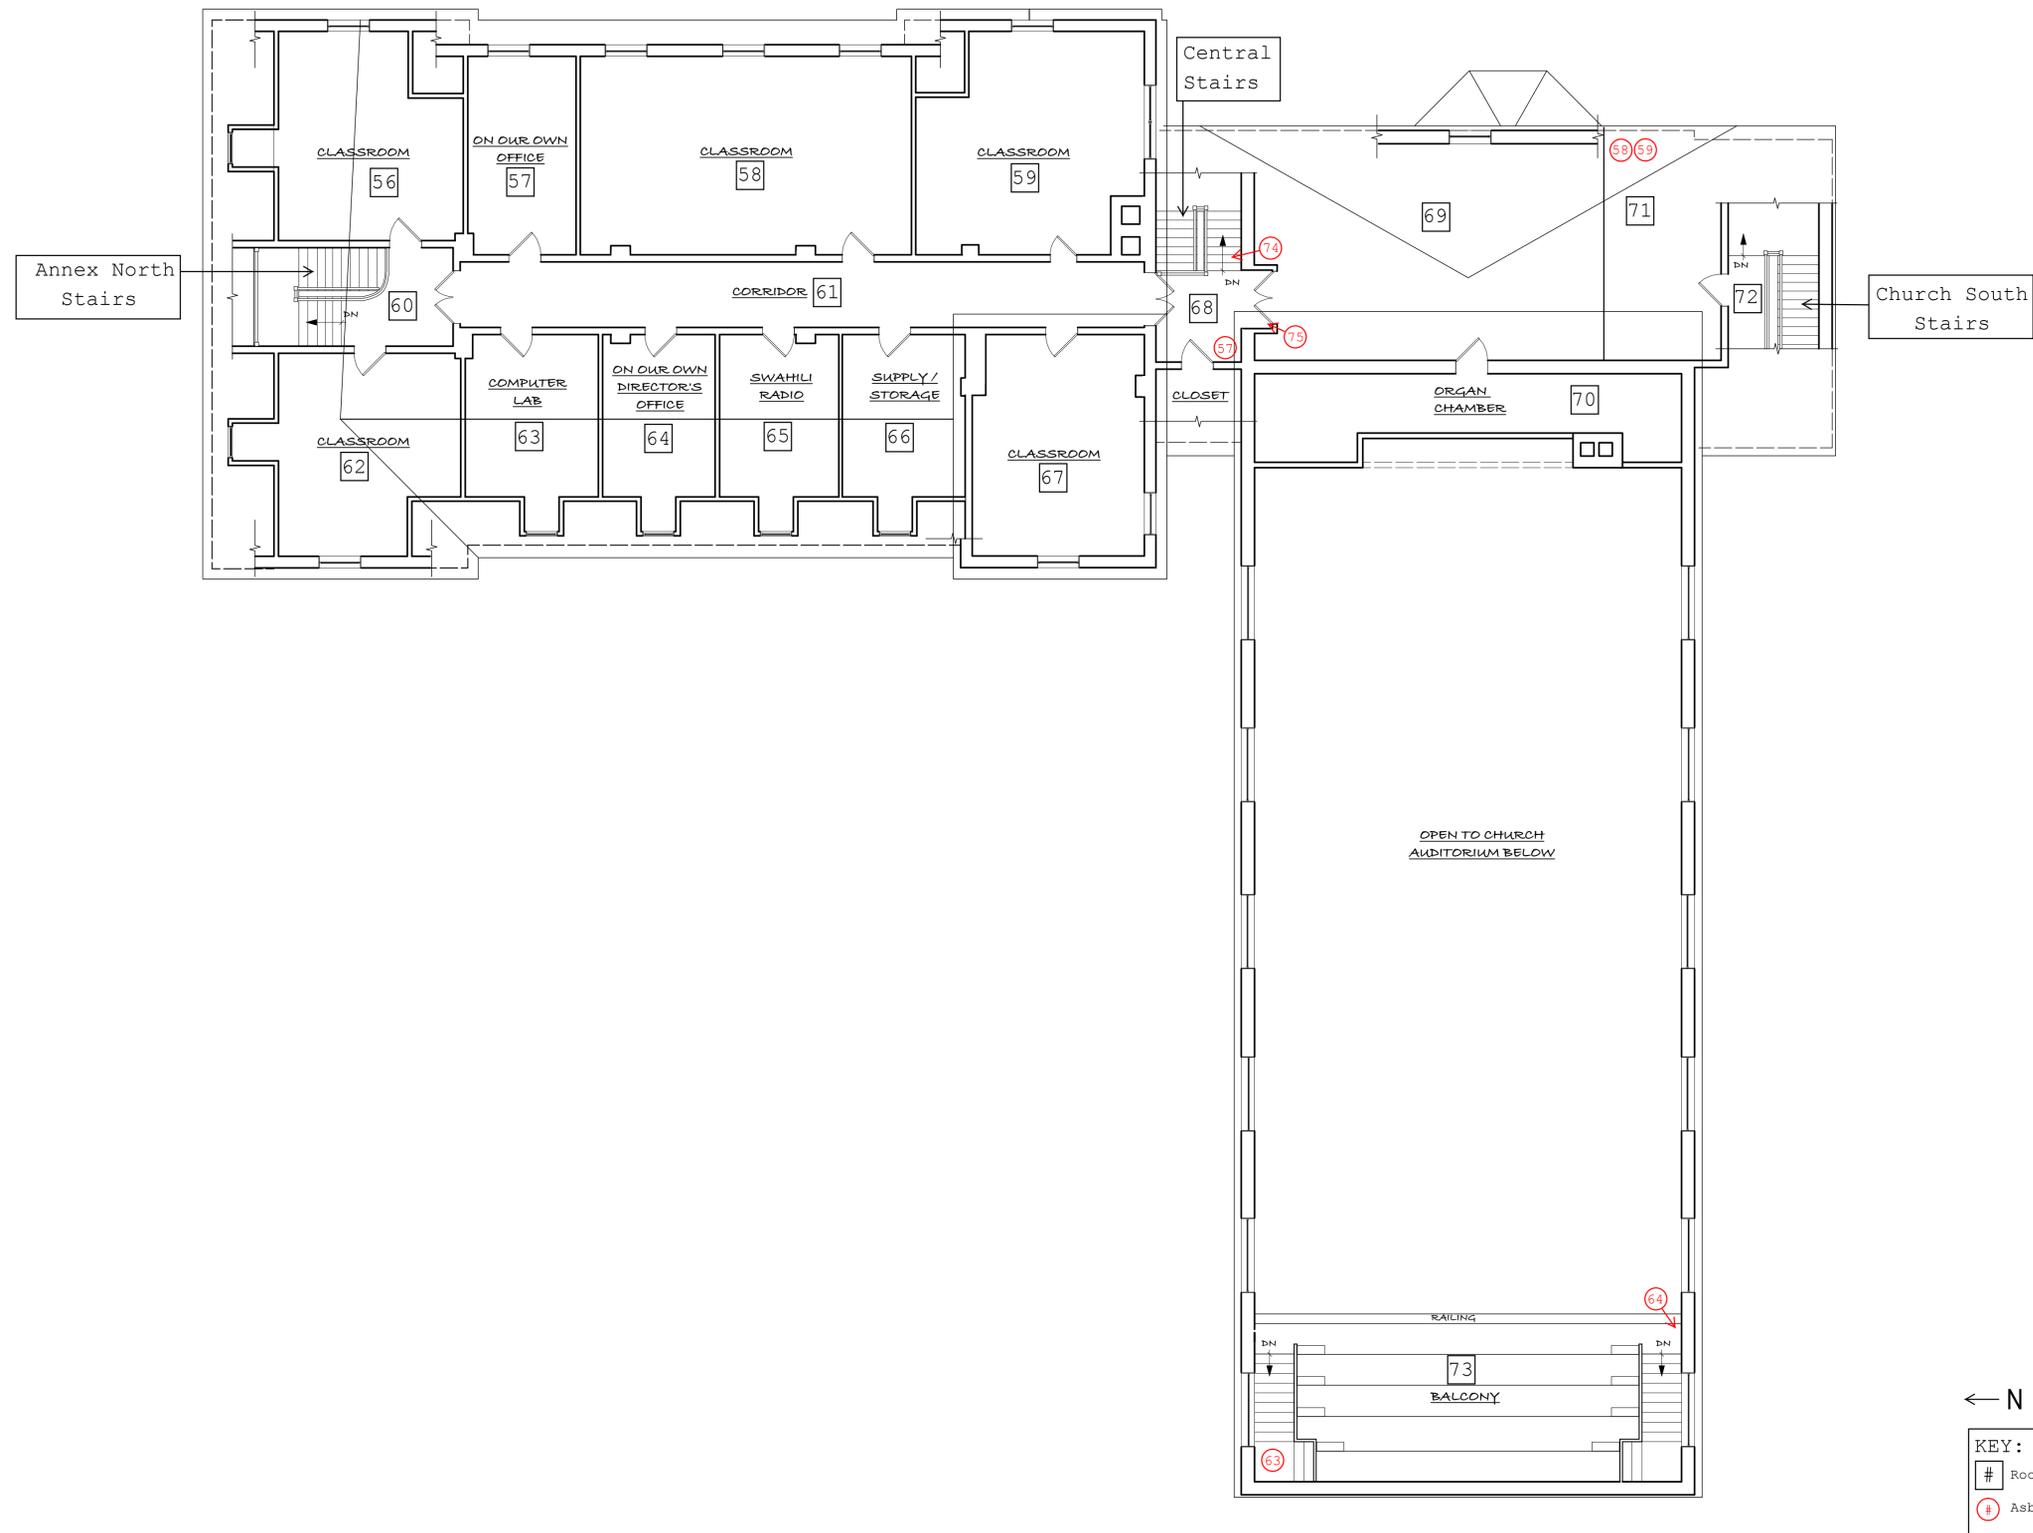
**1** EXISTING SECOND FLOOR  
Scale: 1/8" = 1'-0"

FLOOR AREA  
5,365 SQ.FT.
